Case study – the Netherlands

In Situ Chemical Oxidation using NaMnO₄ and CAP18TM injection :

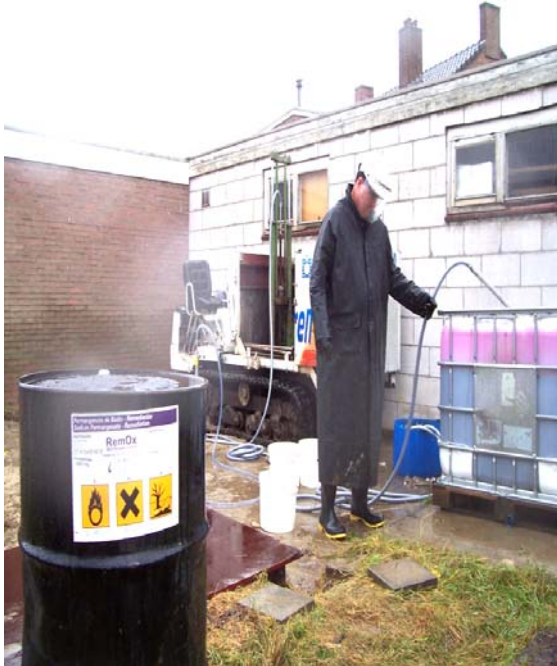
ISCO with NaMnO₄

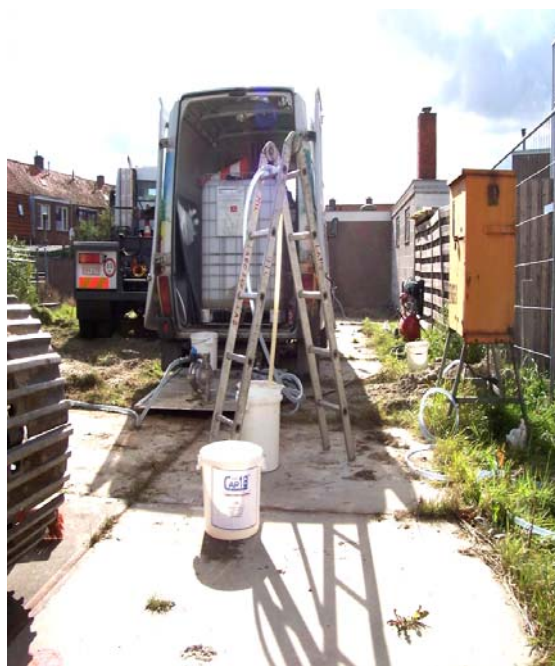
CAP18TM injection
