Case study – Belgium

***In Situ* Chemical Oxidation using NaMnO₄ and anaerobic bioremediation using CAP18™ and CAP18-ME™: A Full Scale CAPISCO™-design**

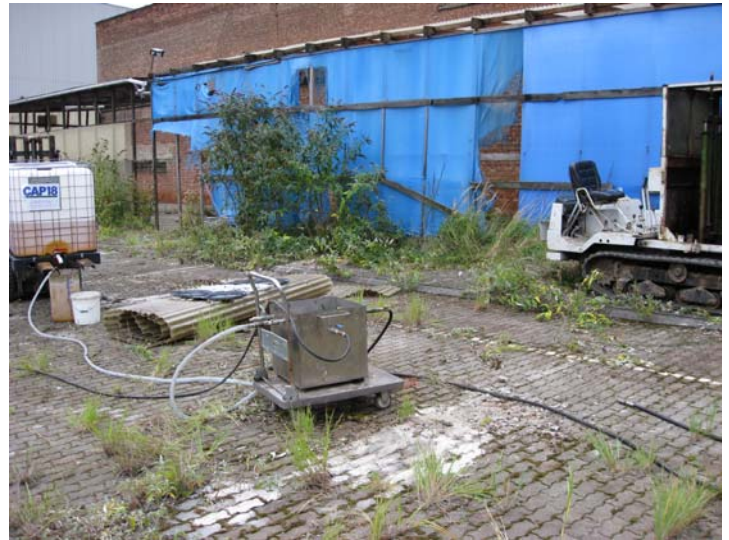
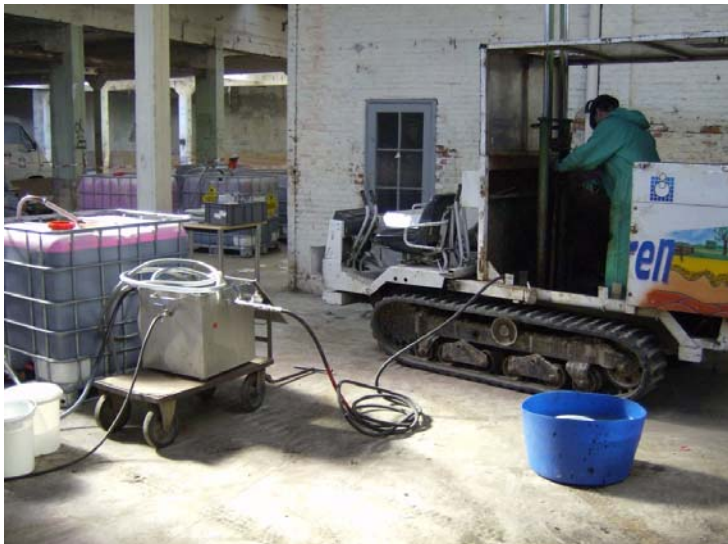
- **Former dry cleaning.**
- **Geology :** very fine to fine sand.
- **Groundwater pollution of :**
 - Tetrachloroethene (PCE);
 - Trichloroethene (TCE);
 - Cis-1,2-dichloroethene (CIS);
 - Vinyl Chloride (VC).
- **Maximum concentrations :**
 - PCE : 49.100 µg/l;
 - TCE : 8.850 µg/l;
 - CIS : 69.000 µg/l;
 - VC : 2.060 µg/l.
- **Injection method :** direct push.
- **Bench test and pilot were positive.**

- **Full scale :**
 - NaMnO₄ :
 - Injection in August 2007;
 - 6.720 kg NaMnO₄ 40%;
 - 44 injectors.
 - CAP18™ :
 - Injection in September 2007;
 - 5.520 kg of CAP18™;
 - 152 injectors.
 - CAP18-ME™ :
 - Injection planned in December 2007;
 - 10.170 kg of CAP18-ME™;
 - 254 injectors.
- **Monitoring :** foreseen till 2012.
